Manhole Inspection Summary

Manhole # S11AA2011MH

Location Address: **5733 ROCKSRPING RD**

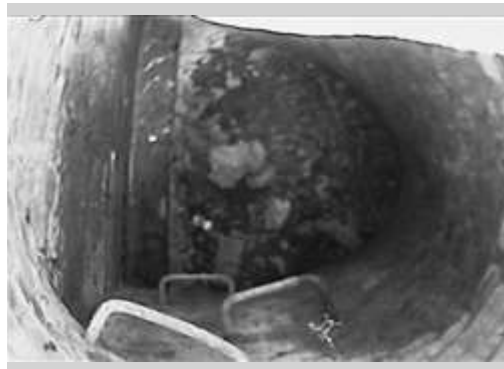
Top View

Bench debris.

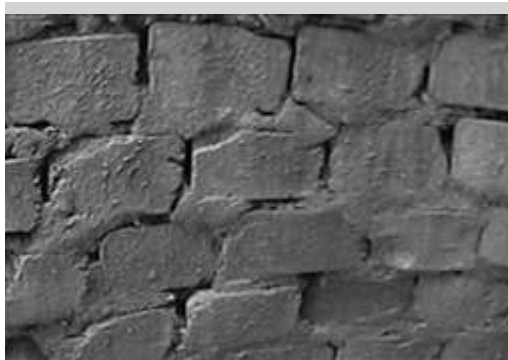
Defect

Barrel deterioration and infiltration.

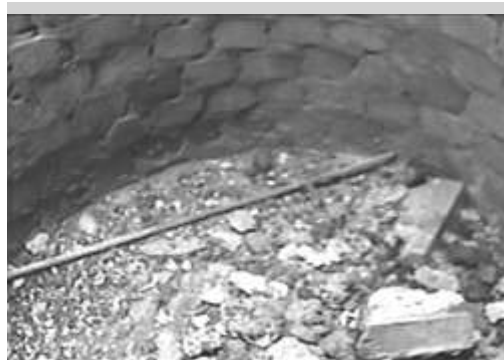
Defect

Barrel deterioration and infiltration. Bench debris.

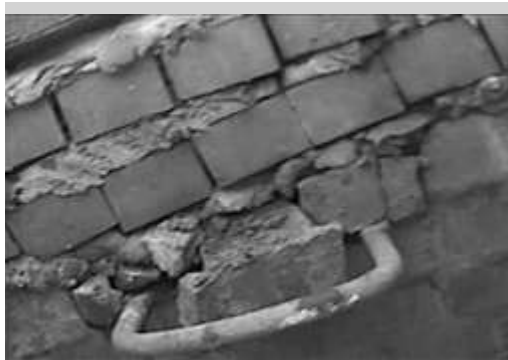
Defect

Adjustment deterioration, loose brick, and infiltration.

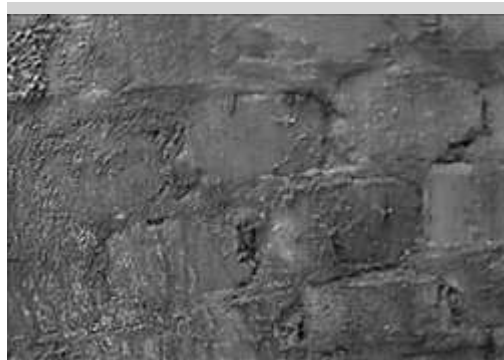
Defect

Corbel infiltration.

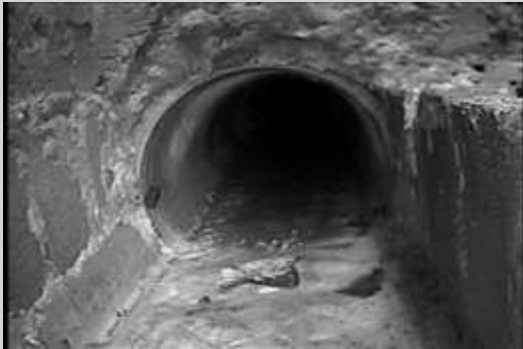
8 in. Circular Gravity Sewer Pipe Out @ 12 O'Clock

Deposits: ☐ None ☐ **Mud** ☐ Sludge ☐ **Debris** ☒ **Grease**

Silt Depth: **0** (in.) Deposits Extent: **Light**

Infiltration: **None** Pipe Seal Cond: **Unknown**

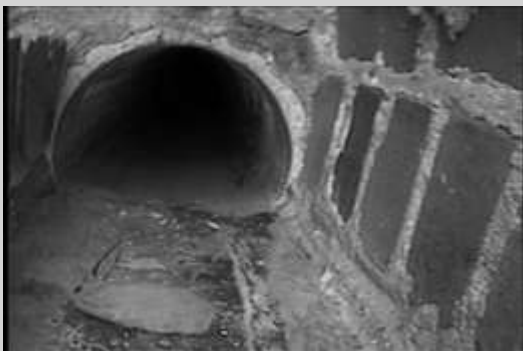
8 in. Circular Gravity Sewer Pipe In @ 6 O'Clock

Deposits: ☐ None ☒ **Mud** ☐ Sludge ☒ **Debris** ☒ **Grease**

Silt Depth: **0.5** (in.) Deposits Extent: **Light**

Infiltration: **None** Pipe Seal Cond: **Unknown**
